## Case Study South Western Railway

# HOW HAS UNISOL'S EXPERTISE IN FIBER SOLUTION HELPED CUSTOMERS?

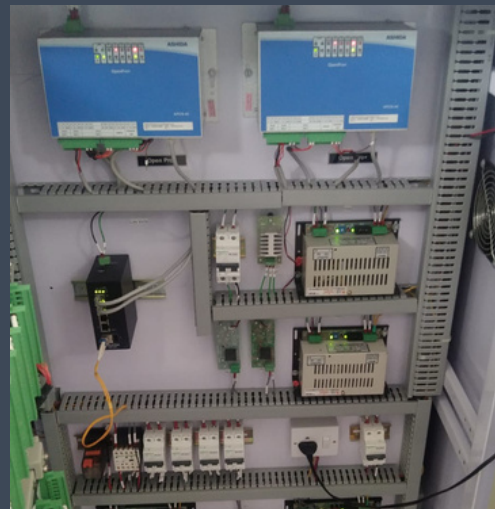
According to customer feedback, Unisol's Fiber Optic Patch Panel/ LIU is not operational, preventing communication with SCADA Panels.

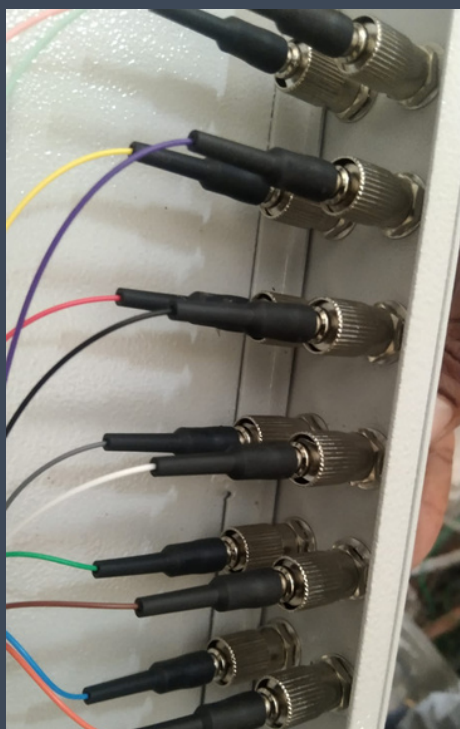
Our engineers visited the site and found the below problems:

- The Fiber Optic Patch Panel/LIU was not properly installed.
- Adapters and pigtails are not connected properly.
- Mismatch in color coding of the fiber core (1 to 1).
- Most of the dust caps were removed from connectors.

- We did OTDR testing on all the fibre cable and found out where the link is getting struck in between.
- Laser light testing on each core to ensure all the cores are working properly.
- We reassembled all the adapters and pigtails.
- Rerun the OTDR and laser light testing and ensure that all 3 links are working satisfactorily.
